Assessment of Regulatory Requirements in Diagnostic X-Ray Facilities in Bangladesh

A. Aktar^{1*}, M. Haider¹, S.M. Islam²

Journal of Nuclear Sciences, Vol. 3, No.2, Dec 2016, 45-49

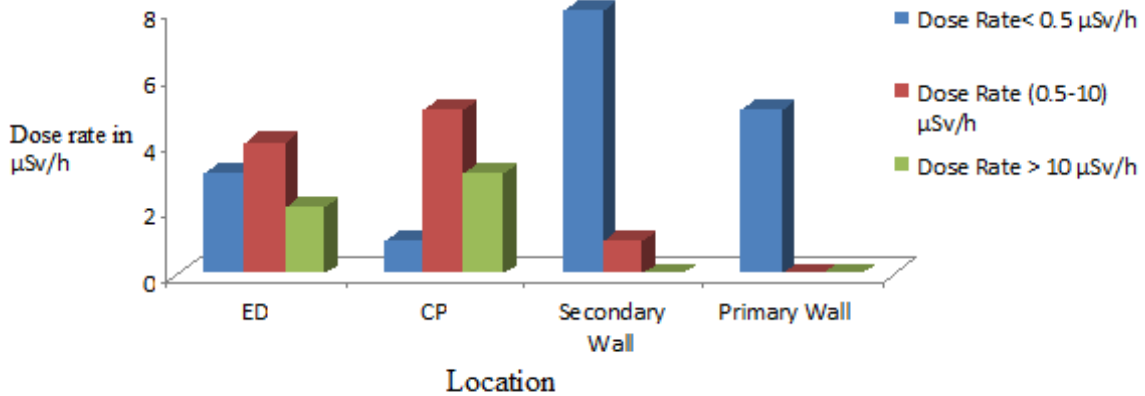
Fig.1 Measurement of radiation dose rate across shielding materials

Fig.1 shows that occupational are receiving doses more than their limit $10\mu\text{Sv/h}$ in the 3 facilities out of the 8 facilities. In other words, 40 % of the total facilities don't comply with regulatory requirements with regards to dose limit for the occupational worker. In 66% facilities, the amount of radiation penetrate through the entrance

door (ED) is more than the permissible limit ($0.5 \mu\text{Sv/h}$) for the public. The area outside the x-room is identified as supervised area where public dose limit is applicable. In most of the facilities radiation is not protected adequately at ED's due to insufficient amount of shielding. Primary and most of the secondary walls of the

x-ray room have been established based on the standards. X-ray rooms are structured with 10-inch brick wall which is the requirement of the standards. As a result, radiation doses hardly penetrate through the walls of the facilities [3].

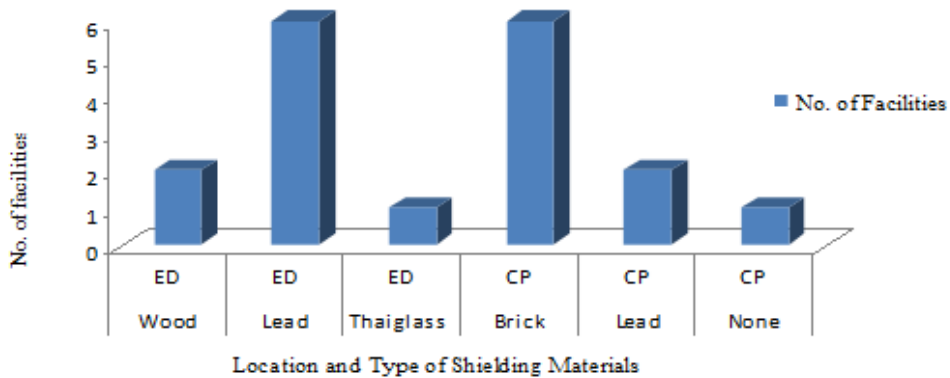
Fig.2 Description of shielding materials used in x-ray facilities

Wood, lead, thaiglass and bricks are found mostly as the shielding materials of the x-ray room. According to standard, wood and thaiglass are not recommended as shielding materials for x-ray room because these materials do not provide any shielding for x-ray radiation. But in some facilities (3) these materials are

being used as shielding materials at entrance door of the x-ray room. Therefore, radiation is coming out through the entrance door and public is being exposed to unwanted radiation.

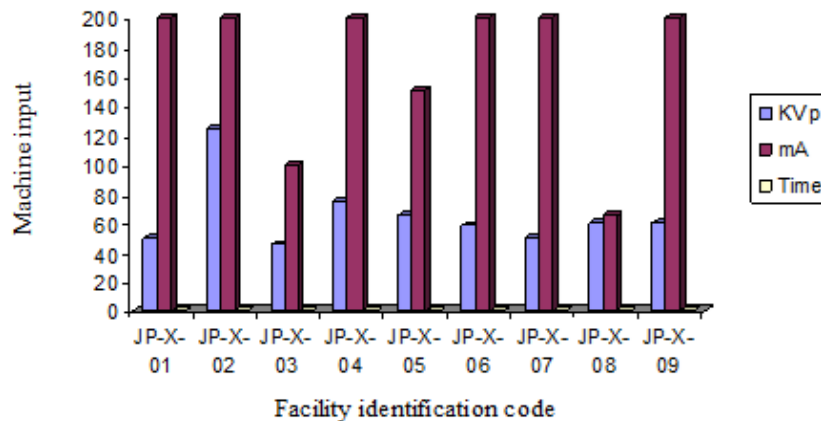
Fig.3 Assessment of machine input settings

In the present study, it has been observed that for the same type of patient study by the same kind of machines for the same type of body's structure different kVp, mA and exposure time selected by the operators in different facilities. Even for the same patient different operator select different input parameters for the exposure. Fig.3 shows variations of kVp, mA and exposure time for lumbar spine (LS) study. Maximum value of mA was

selected 200 and minimum was 60. In case of kVp, maximum 125 and minimum 55 were set up for the patient exposure. The time of exposure varied from 0.1 sec to 4 sec. This type of dissimilarities in selecting machine's parameters may happen due to the unqualified radiographer and lack of awareness on radiation safety of the operator.
