Journal of Nuclear Sciences

Assessment of Regulatory Requirements in Diagnostic X-Ray Facilities in Bangladesh

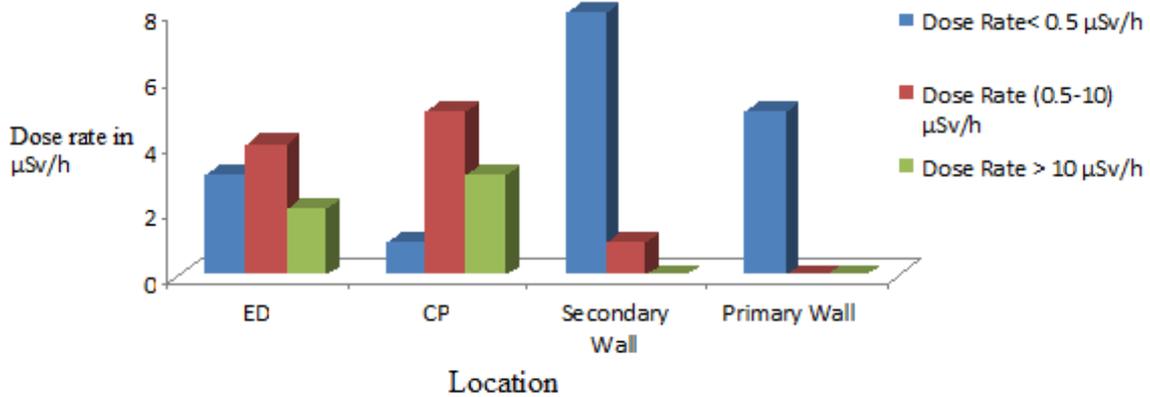
Fig.1 Measurement of radiation dose rate across shielding materials

Fig.1 shows that operators are receiving doses more than their limit 10 μ Sv/h in the 3 facilities out of the 8 facilities. In other words, 40 % of the total facilities do not comply with regulatory requirements in regard to dose limit for the occupational workers. In 66% of facilities, the amount of radiation that penetrate through

the entrance door is more than the corresponding limit (0.5 μ Sv/h) for the public. The area outside the X-room is identified as supervised area where public dose limit is applicable. In most of the facilities radiation is not shielded adequately at entrance doors due to insufficient shielding. Primary and most of the secondary walls of the X-ray room have been established based on the standards. X-ray rooms are structured with 10-inch brick wall which is the requirement of the standards. As a result, radiation doses hardly penetrate through the walls of the facilities [3].

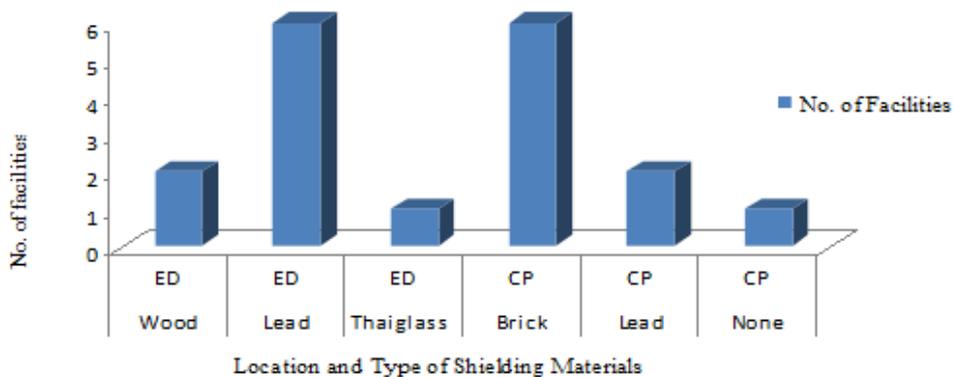
Fig.2 Description of shielding materials used in X-ray facilities

Wood, lead, thaiglass and bricks are used mostly as shielding materials of the X-ray room. According to standard, wood and thaiglass are not recommended as shielding materials for X-ray room because these materials do not provide any shielding for X-ray radiation. But in three facilities these materials are still

being used as shielding materials at entrance door of the X-ray room. Therefore, radiation does likely penetrate through the entrance door and thus public might be exposed to unwanted radiation.

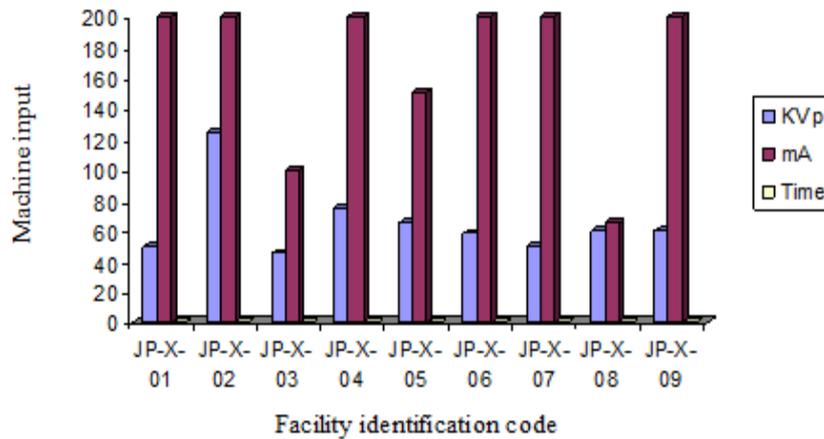
Fig.3 Assessment of X-ray tubes input settings

In the present study, it has been observed in practice that for the same type of patient study using the same kind of X-ray tubes for the same type of body's structure different kVp, mA and exposure time are chosen by the operators in different facilities. Even for the same patient, different operators select different input parameters for the exposure. Fig.3 shows variations of kVp, mA and exposure time for lumbar spine (LS) study.

Maximum current value was selected as 200 mA and minimum as 60 mA. In case of tube voltage, maximum 125 kVp and minimum 55 kVp were set up for the patient exposure. The time of exposure varied from 0.1 s to 4 s. This type of dissimilarities in selecting X-ray tube's parameters may happen due to the unqualified radiographer and lack of awareness on radiation safety of the operator.
