Lakes of Turkey: Comprehensive Review of Lake Çıldır

Cite this article as: Zariç, Ö.E., Çelekli, A, & Yaygır, S. (2024). Lakes of Turkey: comprehensive review of Lake Çıldır. *Aquatic Sciences and Engineering*, 39(1), 54-63. DOI: <https://doi.org/10.26650/ASE20241353730>

Lake Çıldır, situated in eastern Turkey, is one of the most noteworthy freshwater lakes in the region, distinguished for its aesthetic allure and its paramount ecological and socio-economic roles. This review thoroughly examines Lake Çıldır, beginning with an introduction that contextualizes its importance. The climatic conditions influencing the lake's dynamics, its hydrographic characteristics, and the physicochemical variables determining its water quality have been specified. Our review synthesizes findings about the lake's biological attributes, including its varied flora and fauna. Detailed sections are dedicated to the fish species, macrophytes, benthic macroinvertebrates, and phytoplankton that inhabit the lake. Using land cover data, temporal changes in the lake's environmental structure have been evaluated. The lake's trophic state and overall ecological health are critically discussed, shedding light o

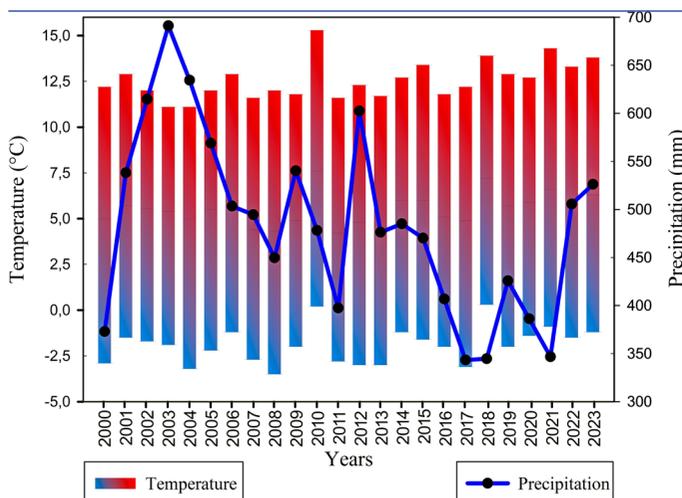
Figure 2. Temperature and precipitation with averages of Lake Çıldır.

knowledge is pivotal for formulating strategies for water resource management, agricultural activities, and the preservation of ecosystems. In this context, an analysis was conducted utilizing meteorological data collated by the Turkish State Meteorological Service from 1931 to 2023 for Kars and Ardahan. Figure 2 shows the precipitation and temperature averages for 2000-2023. As the temperature rises, the decrease in precipitation may pose a problem for species diversity and lake health. The findings indicate that the mean annual temperature for Kars is 4.8°C, reaching a peak in August at 17.8°C and a nadir in January at -10.8°C. Ardahan, on the other hand, exhibits a marginally lower mean annual temperature of 3.7°C, with the highest temperatures recorded in July and August at 16.0°C and the lowest in January at -11.2°C. Concerning precipitation, Kars records an annual average of 506.0 mm, while Ardahan experiences a slightly elevated average of 555.3 mm (Turkish State Meteorological Service, 2018). Notably, May is the month with the highest precipitation in both regions. This characteristic diverges from the typical precipitation patterns observed in other parts of Turkey, where summer is identified as the season with the highest rainfall. Conversely, the winter season is associated with the lowest precipitation levels in both Kars and Ardahan. This climatic information is crucial for developing effective strategies for water resource management, agricultural practices, and ecosystem conservation initiatives.

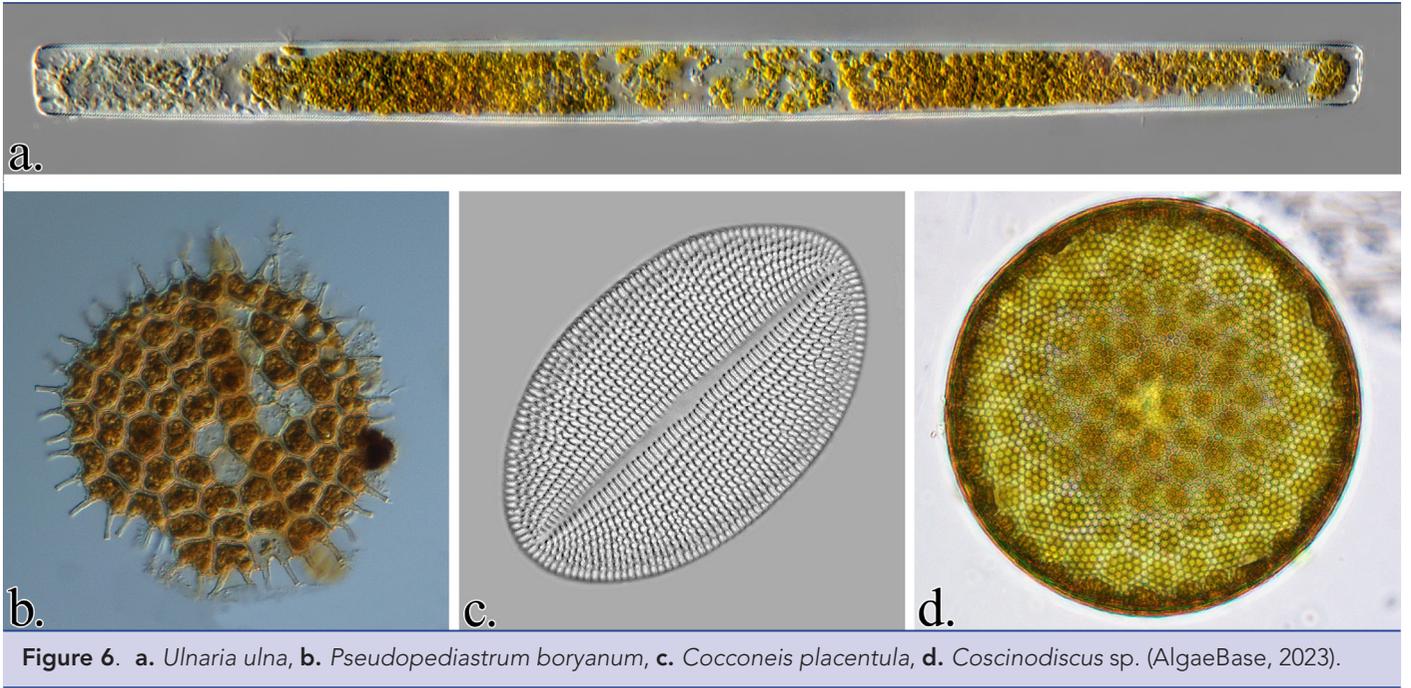
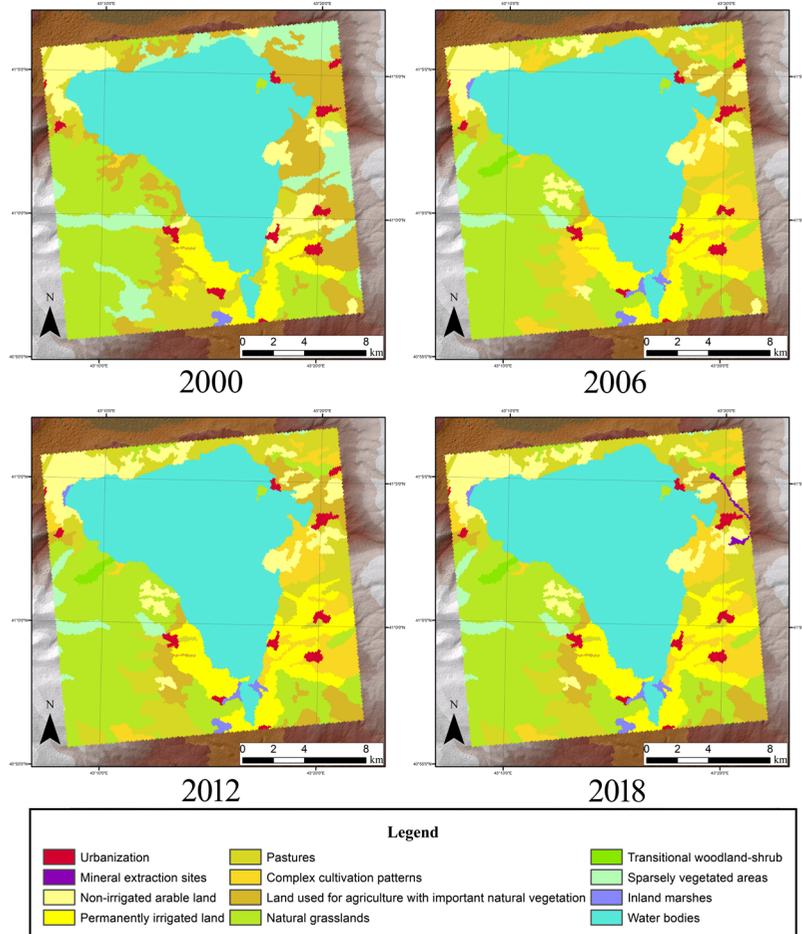
Lake Çıldır has undergone significant land cover transformations from 2000 to 2018. This was analyzed using CORINE Land Cover (CLC) (EAA,2018) data from the Copernicus Land Monitoring Service and visualized using ESRI ArcMap 10.7 software, as demonstrated in Figure 7 and their results are given in Table 2. This amalgamation of satellite, sensor network data, and land cover data allowed for a thorough examination and intuitive comprehension of the spatial distribution and transformations of various land cover types over the studied period.

Lake Çıldır experienced considerable alterations in its land cover between 2000 and 2018, underscoring a significant anthropogenic impact on the region. This period saw an uptick in urbanization, indicating steady urban development near the lake. Concurrently, mineral extraction sites, which were absent until 2006, accounted for a notable proportion of the land use by 2018. Moreover, a marginal increase was observed in irrigated and non-irrigated agricultural lands, hinting at a broader expansion of agriculture in the region. Similarly, the expansion of pastures was observed, which is likely attributable to intensified livestock farming. Conversely, natural grasslands experienced a slight increment, and there was a discernible increase in water bodies, potentially attributable to land use modifications impacting water runoff. These transformations carry profound implications for the ecosystem of Lake Çıldır. The enlargement of agricultural lands and pastures may escalate nutrient runoff into the lake, thereby heightening the risk of eutrophication, a phenomenon detrimental to aquatic life due to the resultant depletion of oxygen levels in the water. Additionally, the advent of mineral extraction sites could adversely affect water quality, contingent on the extraction techniques employed. The augmentation of water bodies might precipitate modifications to the lake's hydrological regime, thereby influencing its water level and, subsequently, its ecological attributes. Furthermore, the marginal alterations in natural grasslands and the reduction in sparsely vegetated areas may engender shifts in the region's flora and fauna, impacting the lake's ecosystem.
